CORNER RECORD (SEARCH)

T 6S R. 30E

R.D. UKIAH County UMATILLA

N.F. UMATILLA State OREGON

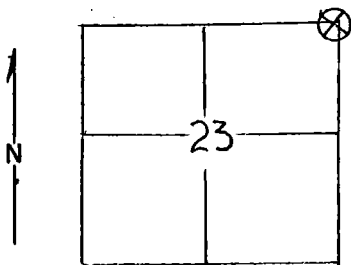
CORNER DIAGRAM

A pile of stones with no markings was 2'x2'x1' and 8" above ground. It was also in poor condition.

A ponderosa pine log bearing S29°W 125 lks. away. It is in poor condition, soon will be rotted away. Attached an attention sign and a location tag to log. Painted 6" red band around it and also painted scribing red. The bt has good scribing on it. At corner location, put two steel posts up with two signs attached to each, an attention and property boundary sign.
