USDA-FOREST SERVICE

File No. W-18

CORNER RECORD (SEARCH)

North Fork John Day

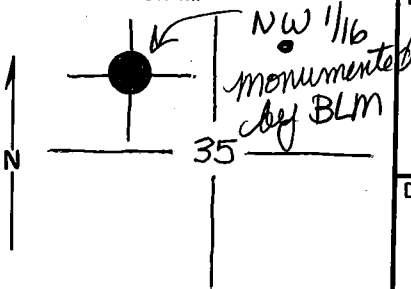
NW 1/16 Cor. 6

CORNER DIAGRAM

Thought to be N.W. 1/16 corner by description given on BT's.
Material - Pipe Size - 12" DBH Height - 2 feet
good condition. Blaze on the N.E. side. I tied pink ribbon
around trees - no other I.D.

Brass Cap, 500 Alum. Fl.

Two BT's - corner found by pacing from two BT's.
1. Bearing Tree - Above road S-608 (N.F. John Day) north side
approx. 60 feet - blazed - Douglas Fir 11" DBH
Sign reads: S 54 E - 42.8 links
T7S, R32E, Sec. 35 (should read T 6 S) NW 1/16 corner
D.B. 9-7-68

2. Bearing Tree - Below road S 608 (N.F. John Day) south side
approx. 8 feet. blazed - Douglas Fir - 11" DBH .
Sign Reads: N 62 1/2 W - 72 feet.
T7S, R32 E, Sec. 35
(should read T 6 S) NW 1/16 corner. D.B. - 9-7-68
Bearing Trees - easily seen from road.
