Index
File No. Z-7
T 6S R. 33E
Merid. WILLAMETTE

CORNER RECORD (SEARCH)

Tract or Survey No. _____ Cor. No. _____
R.D. NORTH FORK JOHN DAY County GRANT & UMATILLA LINE
N.F. UMATILLA State OREGON

CORNER RECORD (PERPETUATION)

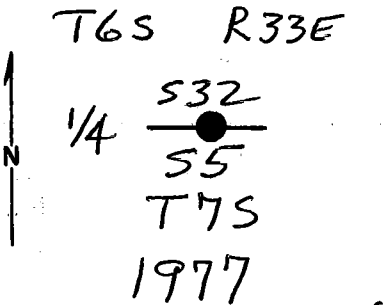
CORNER DIAGRAM

2 1/2" IRON PIPE WITH 3 1/4" BLM BRASS CAP 4" ABOVE GROUND IN A M.O.S.

6 BADLY BURNT PINE STUMP BEARS N63°W, 27° FT. DOWN & BURNT PINE - SCRIBES VISIBLE - ROOT HOLE BEARS S35°E, 67° FEET.

13" DOUG-FIR SNAG - HEALED BLAZE - N13°30'W, 21' FT.
12" DOUG-FIR SNAG - HEALED BLAZE - S28°W, 30' FT.
9" POND. PINE SNAG - CHARRED SCRIBES VISIBLE -

7 BEARS N21°E, 43° FEET.
10" POND. PINE SNAG - BURNT OUT DOUBLE BLAZES - BEARS S15°30'E, 70° FEET.

5/8" rebar w/ brass washer mkd "PLS 1636 S32NE" - N25°30'E, 41' ft.
5/8" rebar w/washer mkd "PLS 1636 S5SE" Bears S43°45'E, 76.9 feet.
5/8" rebar w/washer mkd "PLS 1636 S5SW" Bears S67°15'W, 55.5 feet.
5/8" rebar w/washer mkd "PLS 1636 S32NW" Bears N43°W, 61.5 feet.
