USDA-FOREST SERVICE

CORNER RECORD (SEARCH)

T 7S R. 33E

N.F. UMATILLA State OREGON

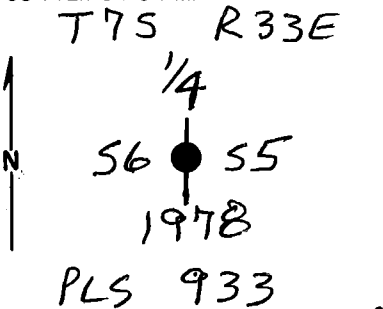
CORNER DIAGRAM

BRASS CAPPED IRON PIPE. CAP MARKED AS IN DIAGRAM.

FOUR LIVE BT'S OF RECORD ARE O.K.

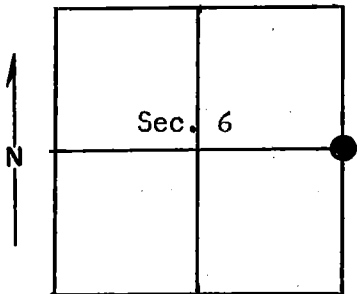
CORNER DIAGRAM

Found stone 18" x 12" x 6" believed to be corner stone.

Found 40" pine stump N 85°10' W 70 lks. (26.4 ft.)
with old sign on stump.

Found 38" pine tree down S 58° E 107 lks. (70.5 ft.)
with old sign, scribe grown over.

Set $2\frac{1}{2}$ " x 30" pipe with brass cap (stamped)
 Pipe is 22" in ground. Placed stone along side cap.

Pine 12" diam. brs. N $28^{\circ}23'$ W 43.40 ft. with signs 54-3 and 54-4 and brass washer.
 Pine 11" diam. brs. N $65^{\circ}49'$ E 17.01 ft. with signs 54-3 and 54-4 and brass washer.

Set steel post 3 ft. West with sign 54-2 and 54-4
